# Application of microCT to the non-destructive testing of an additive manufactured titanium component

## ABSTRACT

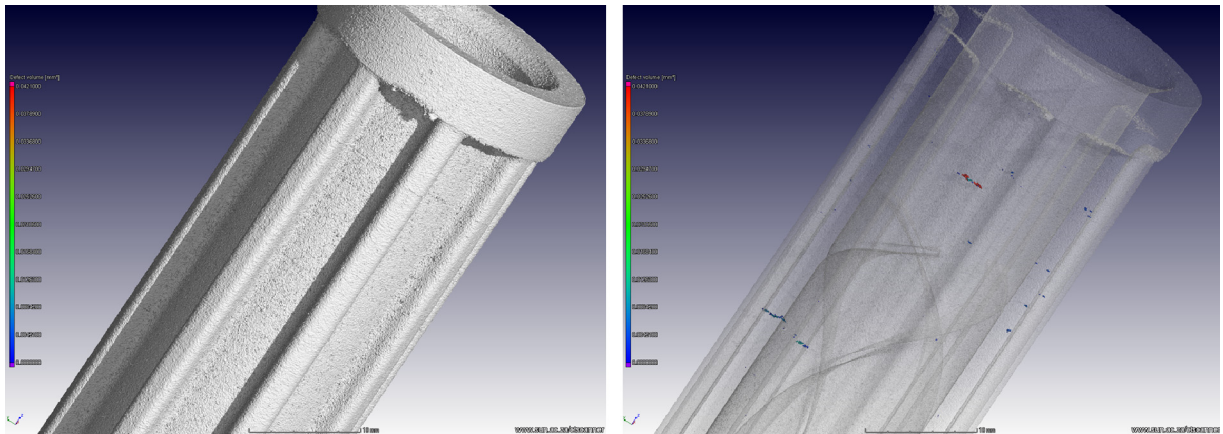
Fig. 1. A 3D view of the sample showing the surface (left) and the defects (right).

The defects are clearly layered or flattened in shape as seen in the 3D image in Fig. 1. In this image, the defects are colour-coded with the largest void in red and smallest in blue. Slice images in Fig. 2 show more clearly the largest void region from top and side views. Clearly, the defects are found in a layered or flattened structure, with the defects in the plane of the laser melting process. This type of defect can be explained by imperfect melting on specific layers as explained in the previous section. This type of defect is difficult to detect by other means such as traditional radiographic testing, due to its size and geometry and the complexity of the object. The average porosity was measured using the automated defect

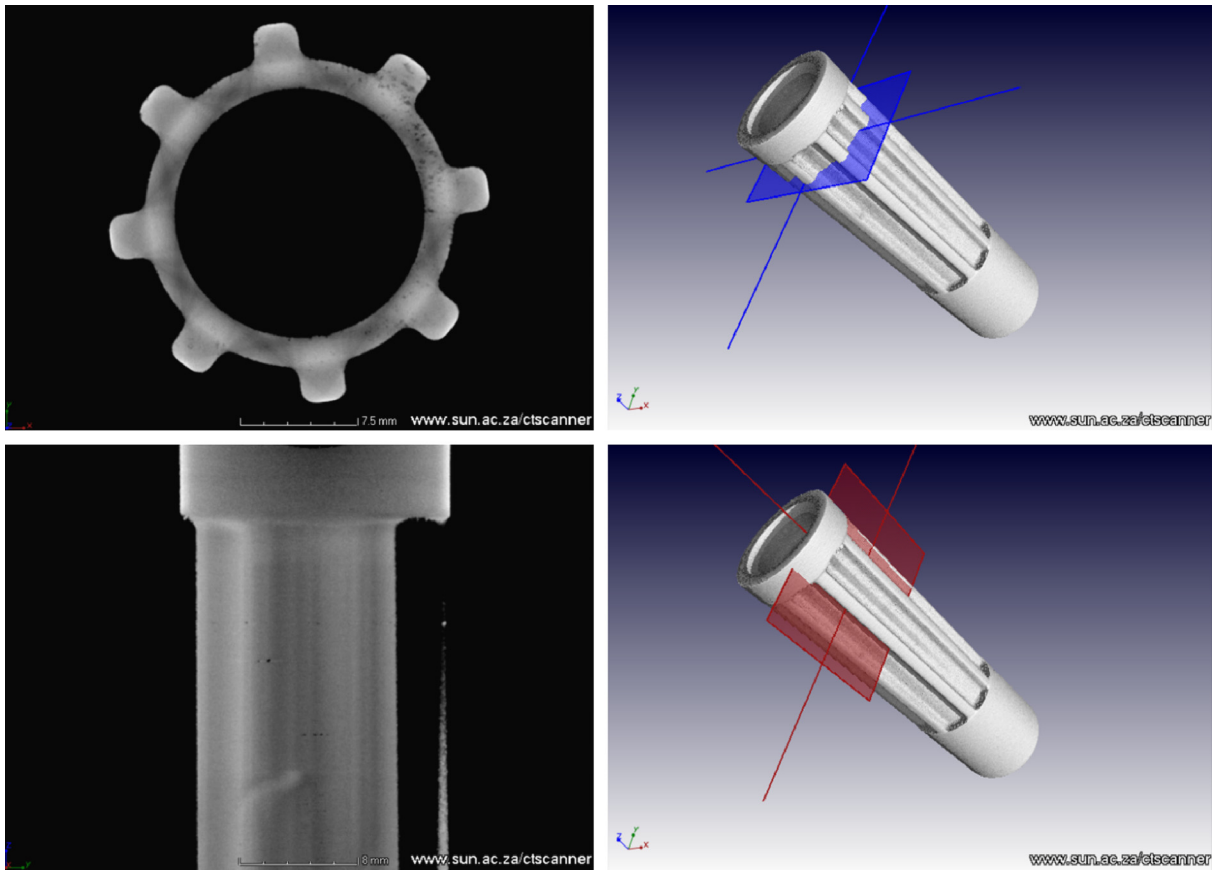
**Fig. 2.** Slice images from the top and side indicate the layered nature of the porosity.

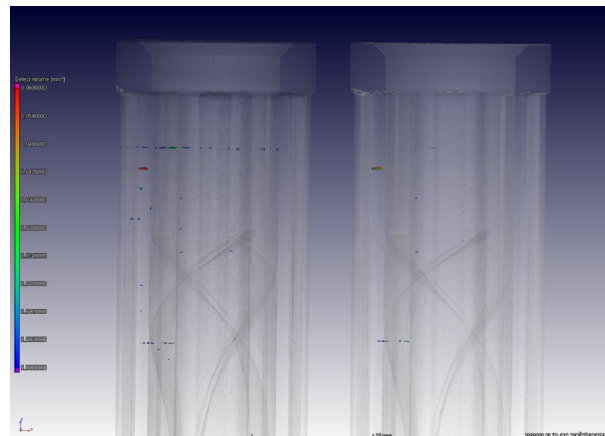
**Fig. 3.** Transparent 3D views before (left) and after (right) HIP treatment indicates qualitatively the lower average porosity after treatment.

Analysis of scans from before and after HIP treatment, using identical scan and analysis settings, indicates a reduced average porosity from 0.005% before HIP to 0.002% after HIP treatment. An automated defect analysis conducted on both samples shows this qualitatively in Fig. 3 in 3D.

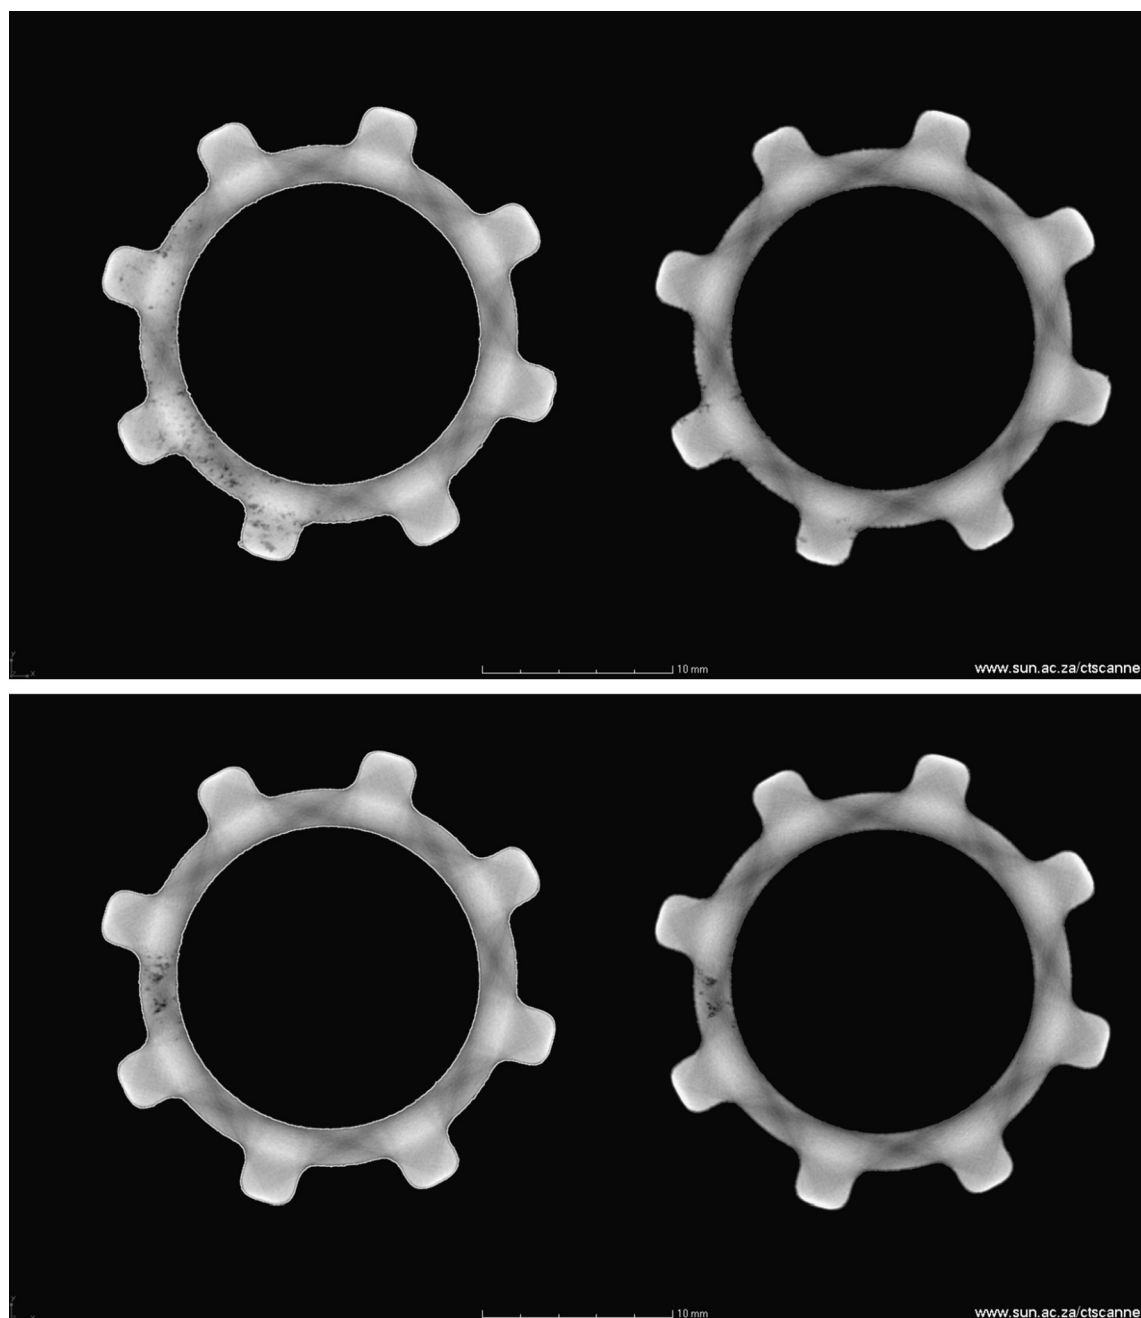
**Fig. 4.** Two examples of slice images side-by-side before and after HIP treatment, for which alignment is crucial. The first example shows porosity that is reduced while the second example shows one which remains unchanged.

In Fig. 4, two examples are shown at different heights along the sample. The first one is where the porosity reduces considerably due to HIPing, except for some pores near the edge of the object, most likely open pores connected to the surface. The second is an example where the pore structure remains effectively unchanged. This is unexpected and could be explained by the pore being connected to the surface via small porosity undetectable at this scan resolution.

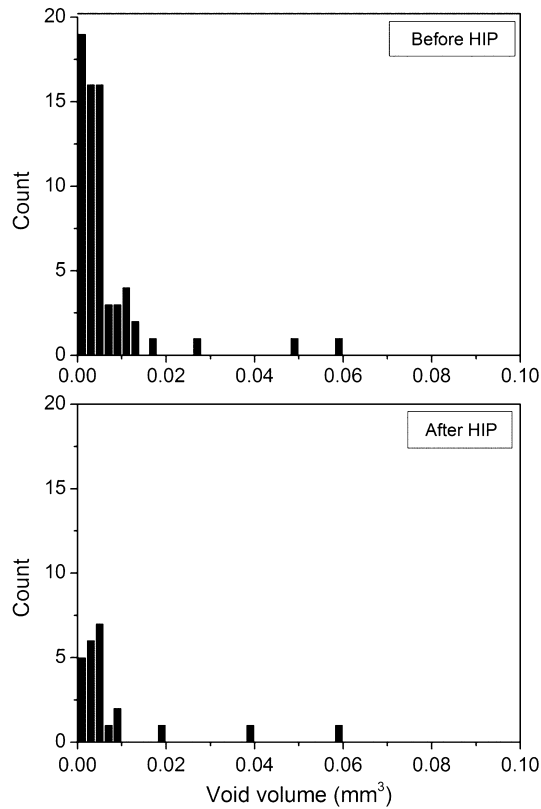
An automated defect analysis can provide statistical information on the pore size distribution before and after HIP treatment. This is shown in Fig. 5, with counts scaled for direct comparison. The total number of pores reduced due to HIP treatment, as expected. The number of the smallest pores reduced considerably, while the largest pores are almost unchanged or only slightly reduced in size.

Fig. 5. Void size distribution before (top) and after (bottom) HIP treatment.

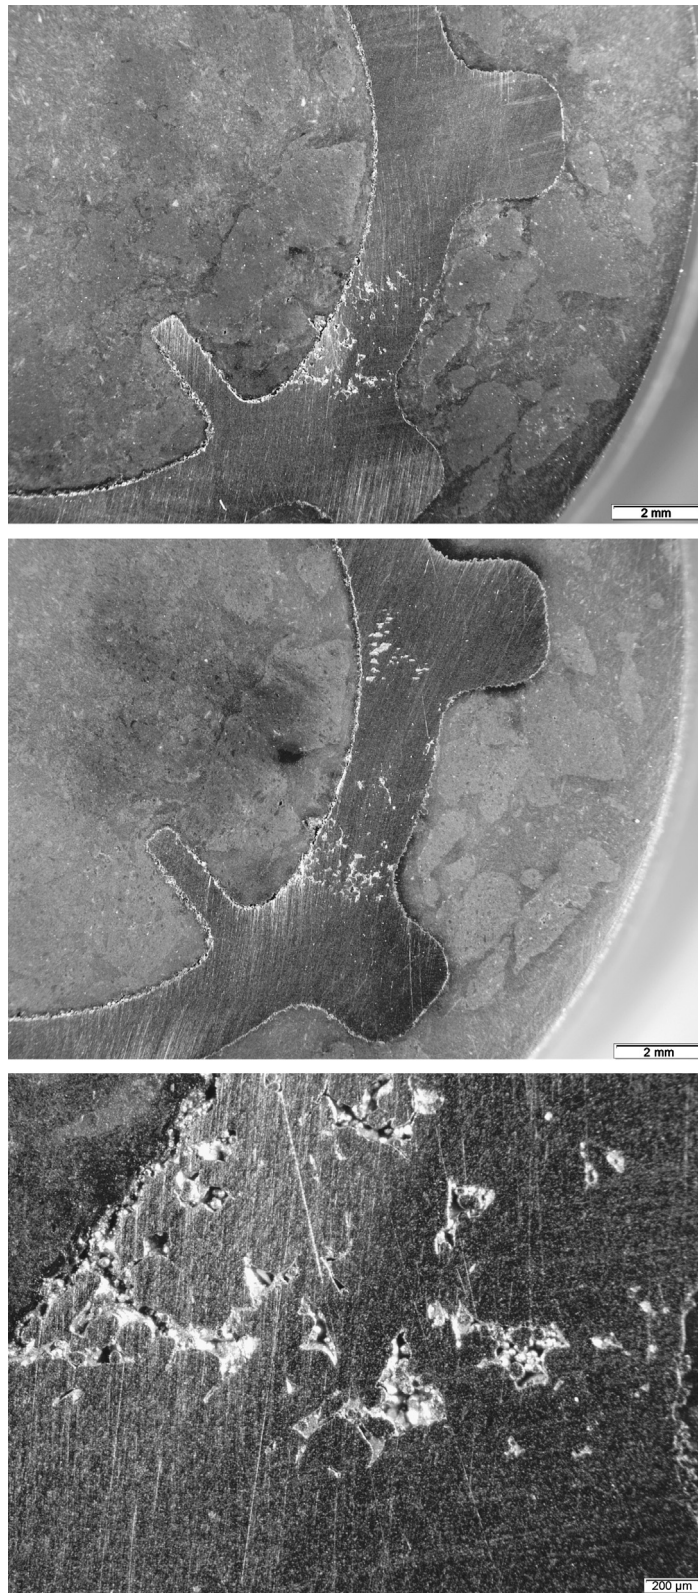
As additional proof of the porosity presence, a physical sectioning of the sample was done. The approximate location of the largest pore region from the CT scan data was used as a guide and physical sectioning and polishing was used producing optical micrographs as shown for two subsequent layers in Fig. 6 top and middle images. A higher resolution closeup view of the porosity region is shown in Fig. 6 as well, confirming the presence of pores indicated by CT scans. Additionally the shapes of the pores are seen to be very irregular.

**Fig. 6.** Sectioning at the location indicated by the CT scans confirmed the presence of porosity in these micrograph images, where top and middle images show subsequent polished layers and the bottom image is a close-up view of the region of porosity in the middle image.
