**Journal of Materials Engineering and Performance**

J. of Materi Eng and Perform  
DOI 10.1007/s11665-015-1580-4

# Investigation of Porosity Changes in Cast Ti6Al4V Rods After Hot Isostatic Pressing

Anton du Plessis and Pierre Rossouw

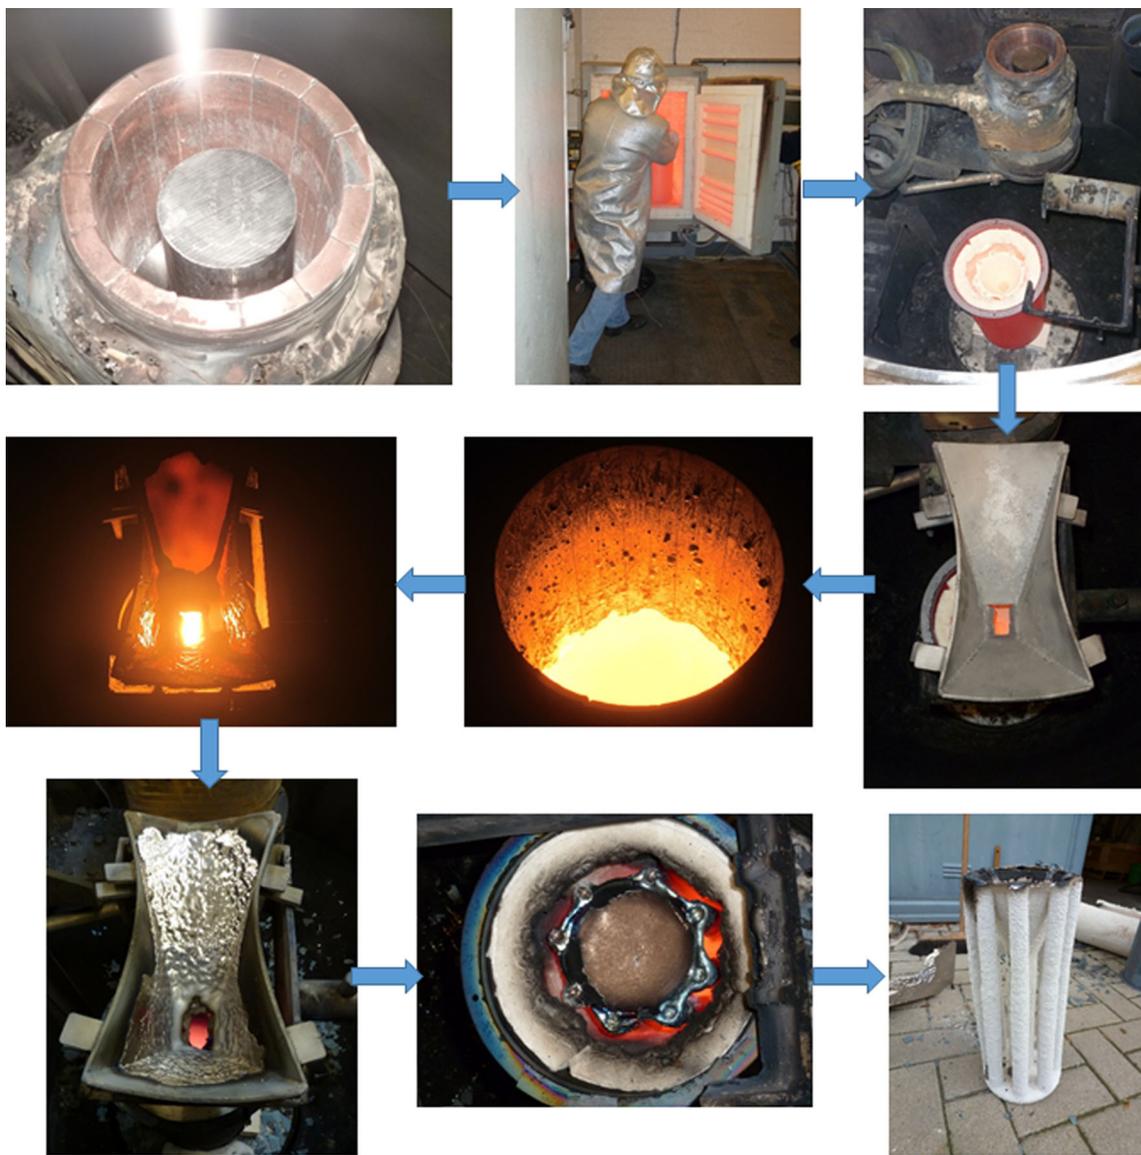
Fig. 1 The melting and casting process

$\text{Ø}15 \times 210 \text{ mm}^2$ -long rod samples were produced using investment casting with Ti6Al4V wrought bar from a single mastermelt. The molds were produced at the CSIR using an Ytria-based and Ytria-stabilized Zirconia face coat system. Molds were cast using copper skull melting under vacuum at the University of Hannover as no facility is currently available in South Africa. Molds were cooled under vacuum for 2 min before removal from the vacuum furnace. The molds were then removed from the insulated tin immediately after removal from the furnace and cooled in still air. The casting process is given in Fig. 1. Figure 2 shows castings after removal of molds, with those that were produced using the Ytria-based face coat castings at the top.

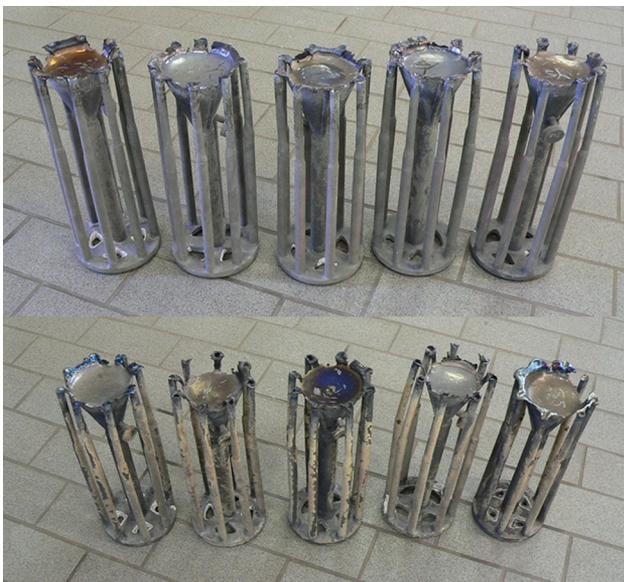
Fig. 2 Sample rods after casting with mold removed

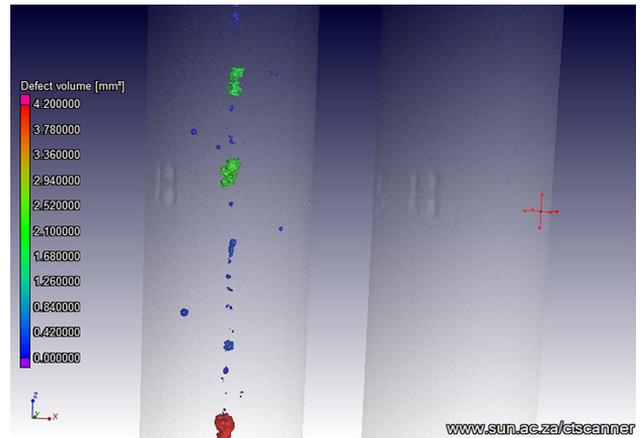
Fig. 3 3D semi-transparent view of one region of the rod S5H before (left) and after (right) HIP treatment. The cross indicates the location of one small pore identified post HIP treatment. 3D videos available as supplementary material

A defect analysis of each pair of before–after volumes was performed identically as discussed in the previous section. The side-by-side views of the before and after volumes are shown in 3D with color coding of pores based on their volume, in Fig. 3, 4, and 5. Figure 3 is a 3D representation with the material semi-transparent to highlight the location of pores. 3D videos of all six samples are available as supplementary material. Figure 4 is a top-view 2D slice image, showing the absence of any void in the location of the largest void before HIPping. Figure 5 shows a side view indicating the same result across all pores in the center of the rod. The top view shows some circular ring artifacts, while the side view shows some stitching artifacts due to multiple scans taken to ensure highest resolution.

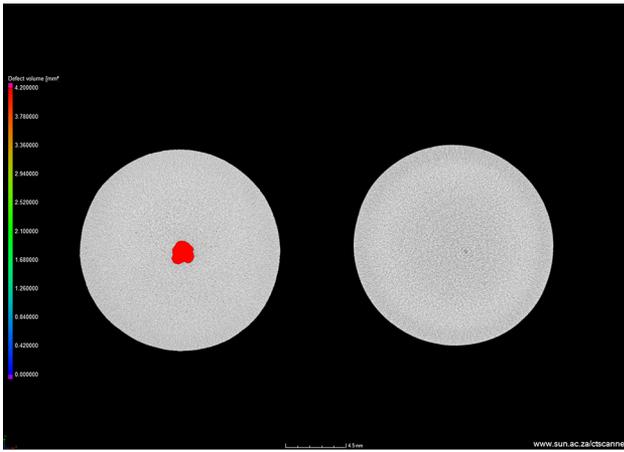
**Fig. 4** Top slice view of sample S5H before (left) and after (right) HIP treatment. The pore diameter is 2.7 mm before HIP

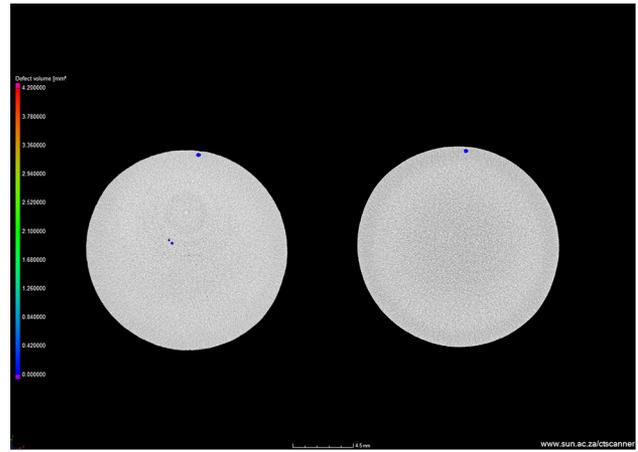
**Fig. 6** Slice images before and after HIPping highlighting one subsurface pore which remains

Some unexpected isolated pores near the surfaces of samples S10E and S5H were identified even though the interiors of these samples are fully dense. A good indicative slice image is shown in Figure 6 (sample S10E), where the internal pore has closed but two isolated subsurface pores remain. Three disk-shaped sections were cut from the rod at the locations of these subsurface pores, for higher resolution scans. One such scan at a higher resolution of 5.6  $\mu\text{m}$  is shown in Figure 7, clearly showing in this slice image that the pore is below the surface. Figure 8 is a 3D view of the same region at high resolution indicating four such pores all are just under the surface, all very spherical in shape. These pores have diameters of 259, 203, 115, and 91  $\mu\text{m}$ , and their nearest edges were measured as 41, 55, 30, and 64  $\mu\text{m}$  from the surface of the rod, respectively.

The presence of these subsurface pores can possibly be explained by the hard and brittle alpha case layer, which may contain small micro- or nanoscale cracks or interconnected pore networks below the resolution limit of the CT scan. If some of these cracks or nanopores connected the large pore to the

exterior, HIP treatment would not be effective, explaining its presence.

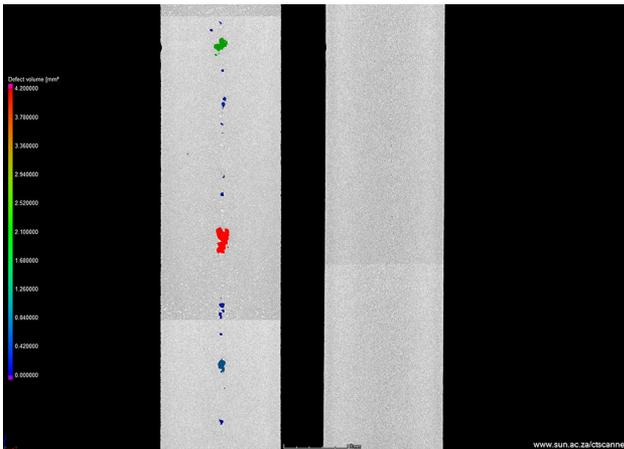
**Fig. 5** Side view of sample S5H before (left) and after (right) HIPping

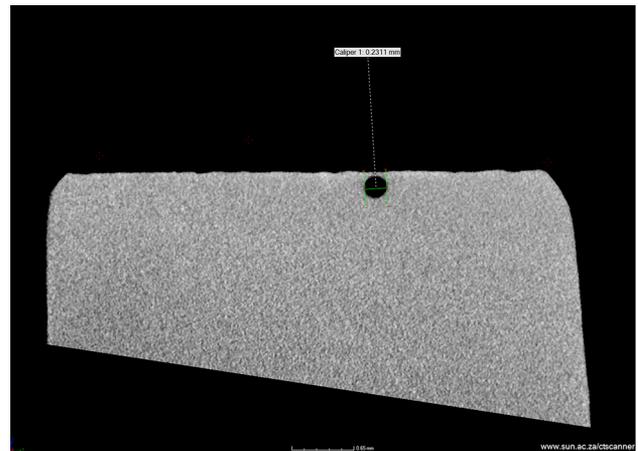
**Fig. 7** Subsurface pore post HIP

A further investigation was done by locating the expected position of the largest subsurface pore in the scanned disk-shaped sample shown in Fig. 7 and 8, and polishing it down very slightly followed by SEM imaging. Figure 9 shows the pore as it has been exposed by the polishing. Though not conclusive, the image shows surface roughness which could be associated with microcracks or pores.

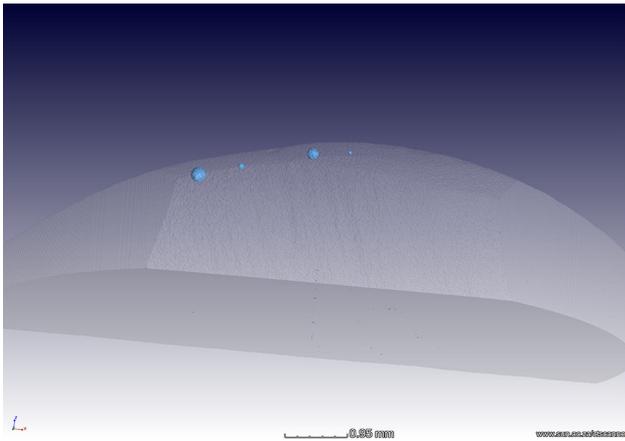
**Fig. 8** 3D view of subsurface pores from 5.8- $\mu\text{m}$  scan (4 pores in blue). 3D video available as supplementary material

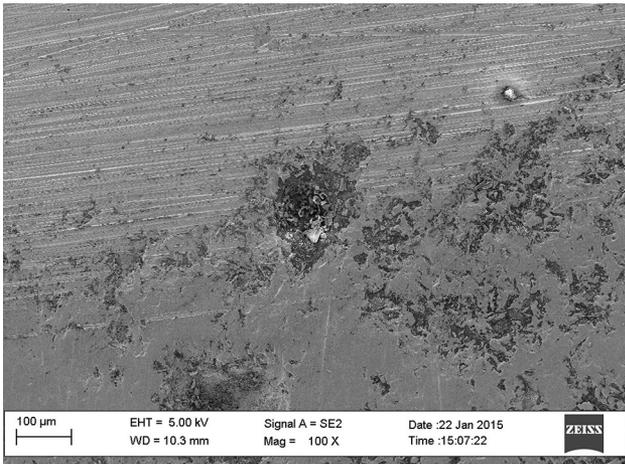
**Fig. 9** SEM image of subsurface pore, taken after polishing off a thin layer of surface material
