Qualification of Ti6Al4V ELI Alloy Produced by Laser Powder Bed Fusion for Biomedical Applications

Rectangular Ti6Al4V extralow interstitials (ELI) samples were manufactured by laser powder bed fusion (LPBF) in vertical and horizontal orientations relative to the build platform and subjected to various heat treatments. Detailed analyses of porosity, microstructure, residual stress, tensile properties, fatigue, and fracture surfaces were performed based on x-ray micro-computed tomography, scanning electron microscopy, and x-ray diffraction methods. The types of fracture and the tensile fracture mechanisms of the LPBF Ti6Al4V ELI alloy were also studied. Detailed analysis of the microstructure and the corresponding mechanical properties were compared against standard specifications for conventional Ti6Al4V alloy for use in surgical implant applications. Conclusions regarding the mechanical properties and heat treatment of LPBF Ti6Al4V ELI for biomedical applications are made.

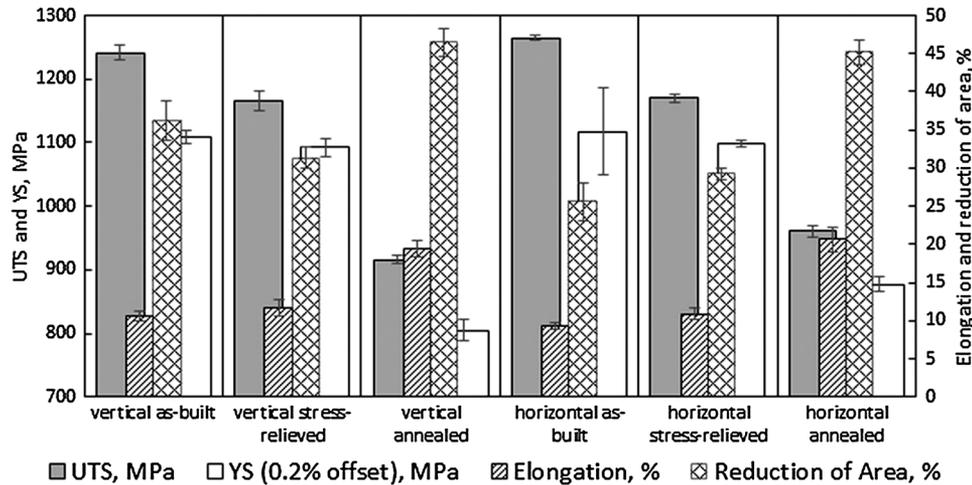
Fig. 1. Tensile mechanical properties of Ti6Al4V ELI samples.

Tensile tests were performed to investigate the influence of heat treatment on the mechanical characteristics of the specimens manufactured in horizontal and vertical directions. The modulus of elasticity did not vary significantly among the specimens and lay in the range of 110–119 GPa. The dispersion of data points in the tensile data around the mean value was more pronounced among the horizontal samples (Fig. 1). The as-built samples exhibited higher ultimate tensile strength (UTS) compared with the stress-relieved and annealed specimens. Higher strength and lower ductility of as-built samples can be explained by presence of residual stresses and fine martensitic structure.⁵ High strength characteristics are typical for as-built LPBF Ti6Al4V.^{2,4,6} After stress-relief heat treatment, the UTS decreased by 6–8% from the initial, as-built level. The yield strength (YS) after stress-relieving heat treatment did not change in comparison with as-built samples. Annealing led to significantly improved ductility of LPBF Ti6Al4V. Elongation at break was increased up to 20%, and reduction of area reached values above 46%. These changes in properties resulted from changes in the microstructure, which became close to conventional.

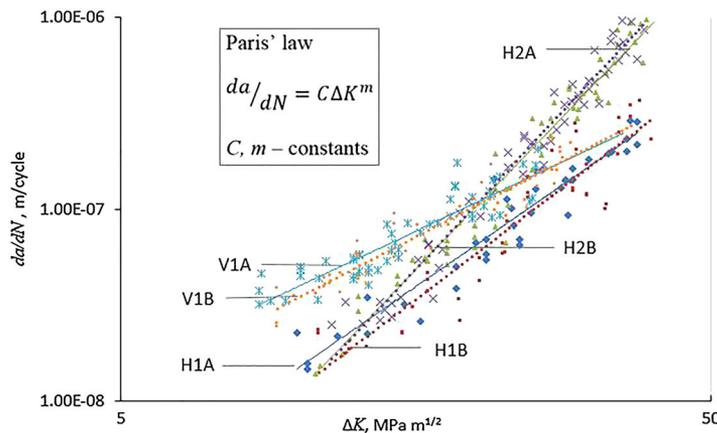
Fig. 2. Fatigue crack propagation rate and cycles to failure of LPBF Ti6Al4V ELI.

The crack propagation rate was investigated based on electron microscopy observations of striations on fracture surfaces (Fig. 2). Unlike previous reports,^{7,8} the crack penetration behavior was found to depend on specimen orientation. The influence of residual stresses on the crack propagation behavior, according to the data obtained in this study, was not great. It was observed that parameters for materials manufactured with the same orientation in as-built and stress-relieved conditions varied insignificantly.

the top surface, or vertical specimens. These differences in crack propagation rate can be explained based on the interaction of the crack with microstructural features and interfaces in the LPBF material. For specimens manufactured horizontally and tested at the top surface, the layers have crack arrester orientation (Supplementary Table SIV). Interaction of a crack with internal interfaces can therefore result in crack deviation, thus decreasing the crack propagation rate. In horizontal specimens tested at the side surface, layers have crack divider orientation, therefore resisting crack growth more efficiently. The lowest crack propagation rate was observed for vertical specimens, for which interlayer interfaces were in-plane with the crack growth direction.

boundaries are more important in specimens tested with this orientation. In vertical specimens, the crack penetrates perpendicularly to the boundaries of columnar prior β -grains. In these specimens, the m value is the lowest; i.e., the crack propagation rate is also low. These specimens showed the lowest number of cycles to failure, and the observed crack before the final failure occurred was shorter compared with the horizontally manufactured specimens. Thus, prior β -grain boundaries seem to be efficient in terms of resistance to fatigue crack propagation, but the material showed the lowest fatigue life.

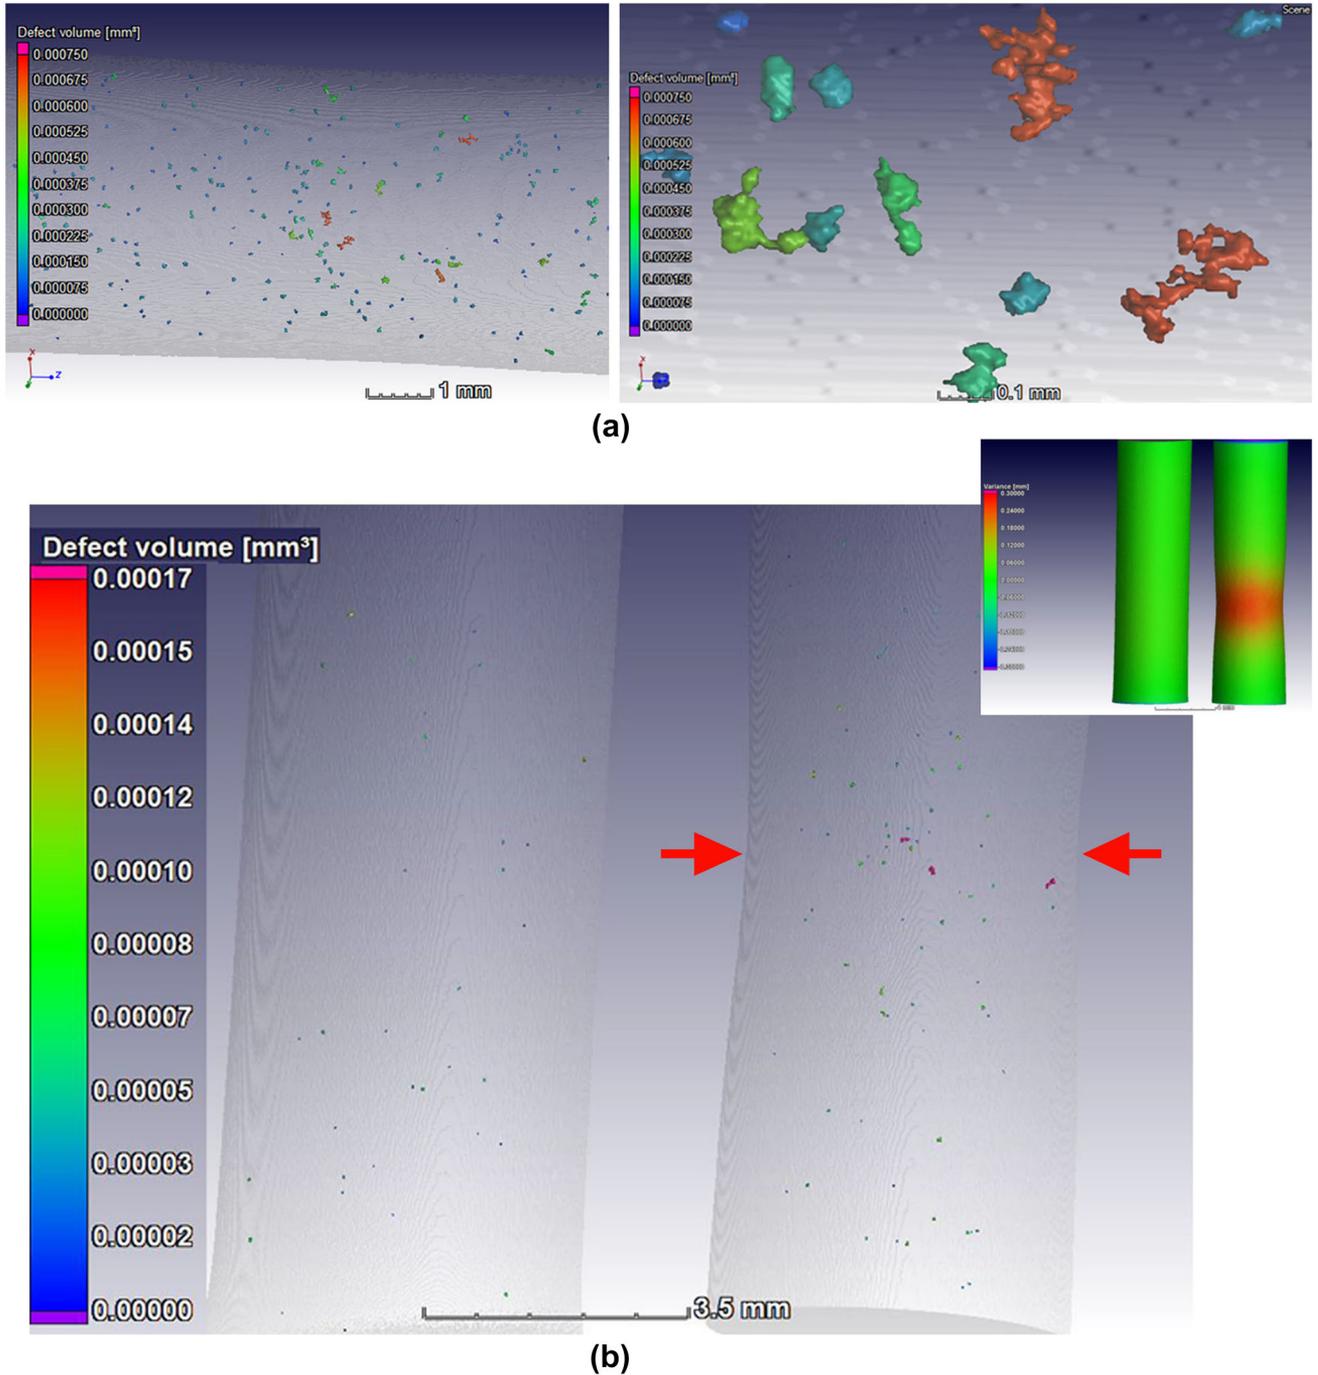
Fig. 3. Reconstruction of porosity in as-built sample deformed to 8.2% from initial length (a) and necking creation in stress-relieved sample deformed from 3.55% to 9.44% from initial length (b). Defect analysis shows color-coded porosity distribution in transparent three-dimensional (3D) views. Inset shows colour-coded thickness variation, clearly indicating the necking region.

Cup-and-cone morphology is typical for fracture controlled by pore coalescence mechanisms. The process of pore formation and coalescence was investigated by means of micro-computed tomography. The as-built and stress-relieved specimens were prestrained to 1.57–9.44%, and the pore sizes were investigated. MicroCT scans showed pore coalescence under loading in the prestrained samples; these pores looked like agglomerates of several pores (Fig. 3a). Some pores were interconnected via quite thin channels, possibly representing the initial stage of formation of cracks or new pores. As the specimen was strained, pore coarsening became clearly pronounced and became dominant in the necking area (Fig. 3b). The number of pores identified by microCT scans significantly increased in this region. Analysis of the cumulative frequency

distributions of equivalent pore diameters in prestrained, as-built, and stress-relieved samples revealed that pores became larger with increasing strain. Most of the new pores were observed in the neck region, and they act as nucleation points for cracks, leading to final failure.^{3,10}
