# X-ray computed tomography inspection in metal additive manufacturing: the role of witness specimens

Prof Anton du Plessis, Stellenbosch University, South Africa

Invited talk, 4th Symposium on Structural Integrity of Additive Manufactured Materials and Parts, Washington, 9 Oct 2019

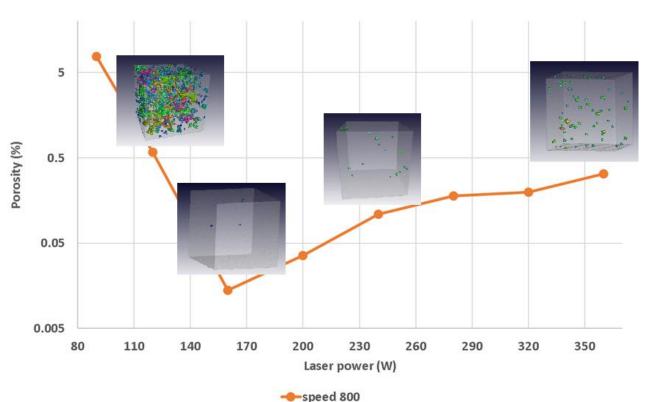
#### Major cause of porosity is wrong process parameters

- By using high resolution X-ray tomography, it is possible to visualize and quantify LoF vs keyhole mode pores and other forms of typical pore formations and distributions resulting in final parts
- Used small cubes and quantification of porosity from <0.05% to >5%
- Found sharp transition from "ideal" to LoF, with decreasing power

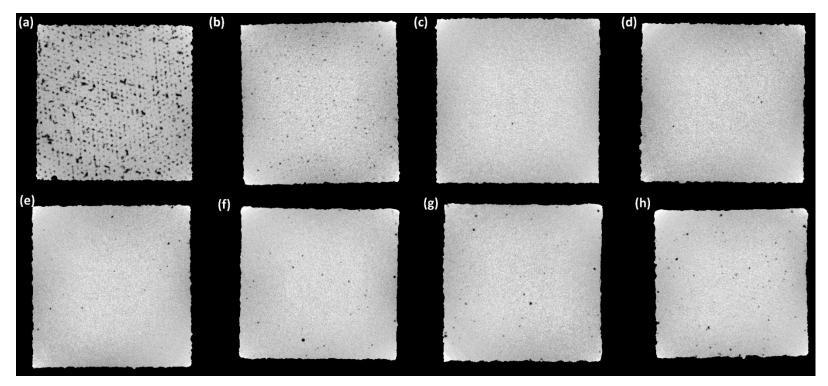
#### Morphology and distribution of pores

- Excessive LoF causes regular spaced pores, with irregular morphology
- Keyhole is rounded and randomly distributed

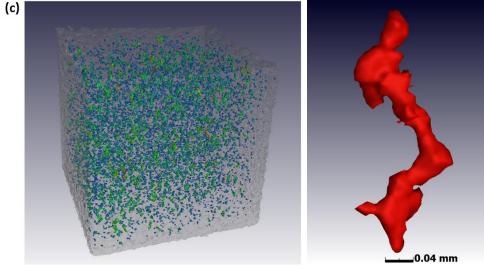
#### Hatch spacing increase

- Vertically oriented LoF pores

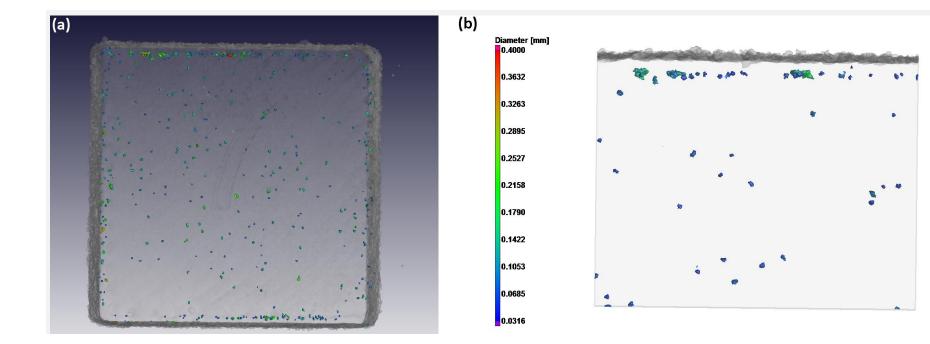
#### Contour-hatch track spacing

- Pores mainly near surfaces

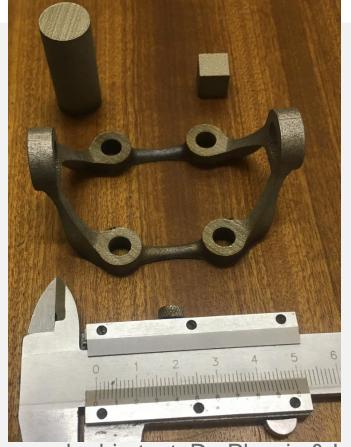
#### Goal of the AM round robin tests

- Aim was to demo "prescribed CT scan parameters & image analysis recipes" – towards standardization
- Commercial systems used at service centers and R&D labs across 3 continents: ID confidential
- All Ti6Al4V, no post processing besides support removal
- All built with > 99.8% density, with aim to be good parts
- Typical errors are highlighted which are still present often in AM parts

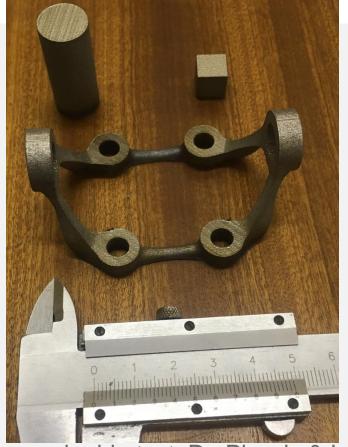
#### Same parts built on various L-PBF systems

- 10 mm cube coupon sample for porosity quantification and visualization
- Topology optimized bracket = example of complex part of interest
- Witness specimen (cylinder) built alongside bracket

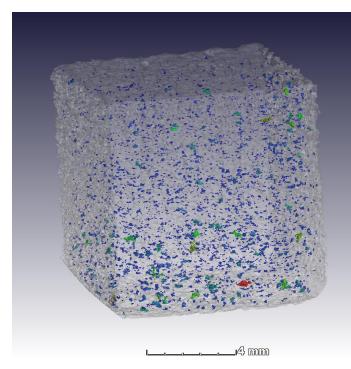
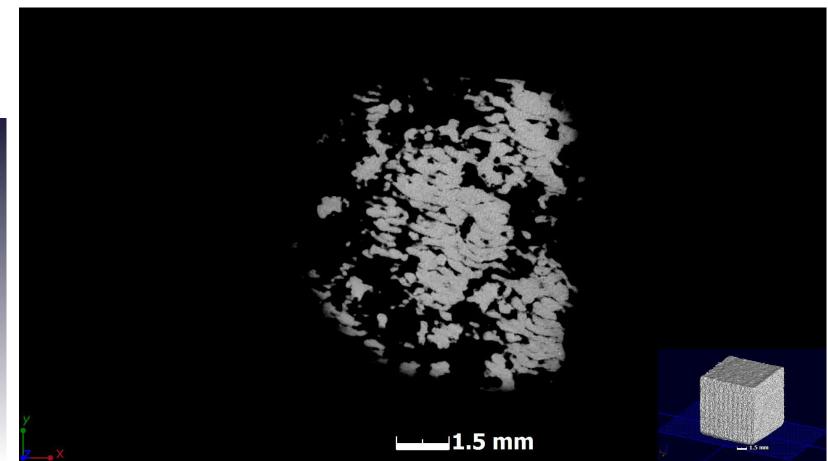
#### Example of LoF porosity

This example is the most extreme case of 0.13% porosity

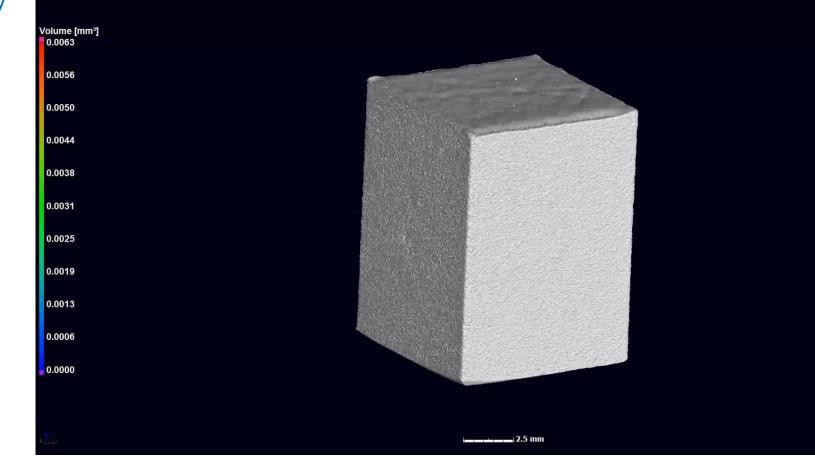
#### Example of contour porosity

- Only at contours

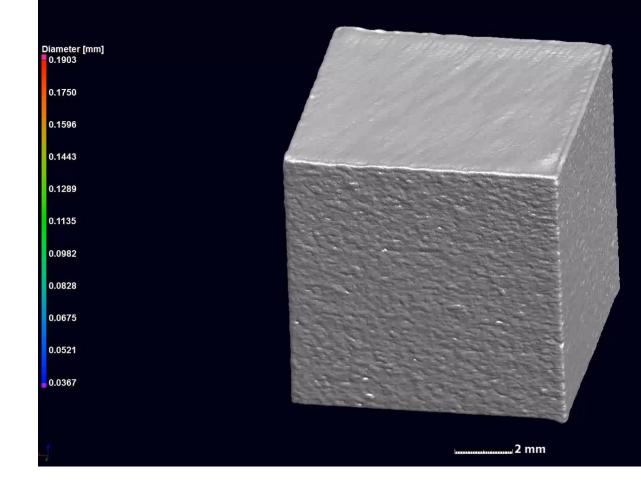
#### Example of upskin porosity

- Only at top surface

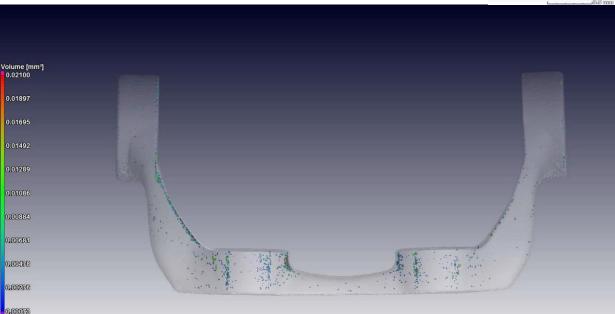
#### Contour porosity

- Can be seen in witness
- And also present in complex part

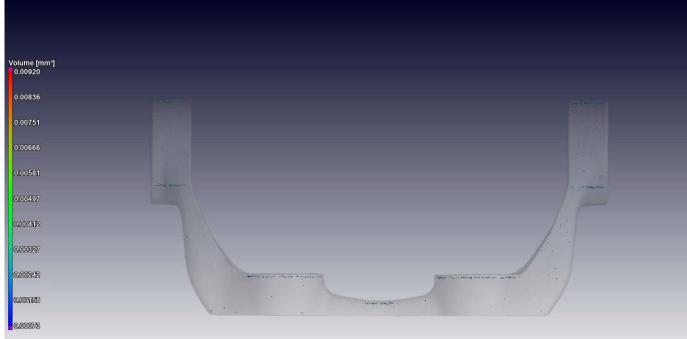
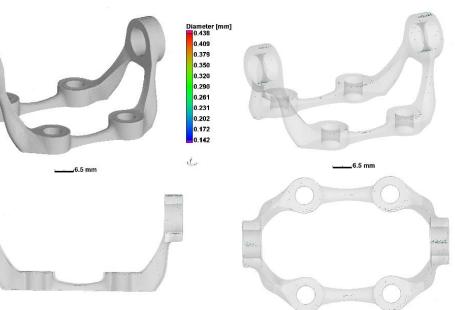
#### Upskin pores

- Can be seen in witness
- And also present in complex part

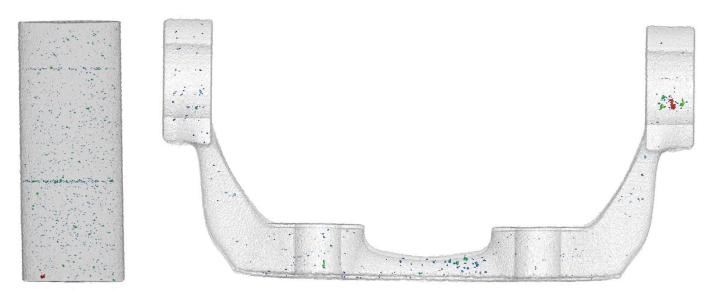
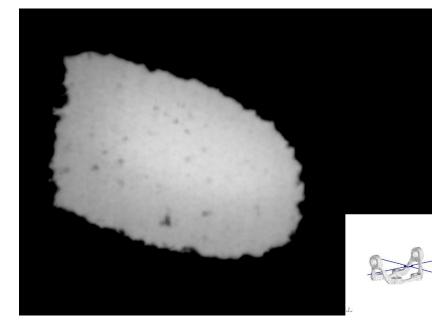
#### Layered lack of fusion flaws

- Can be seen in witness
- Also present in bracket

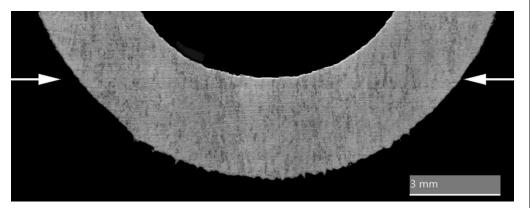
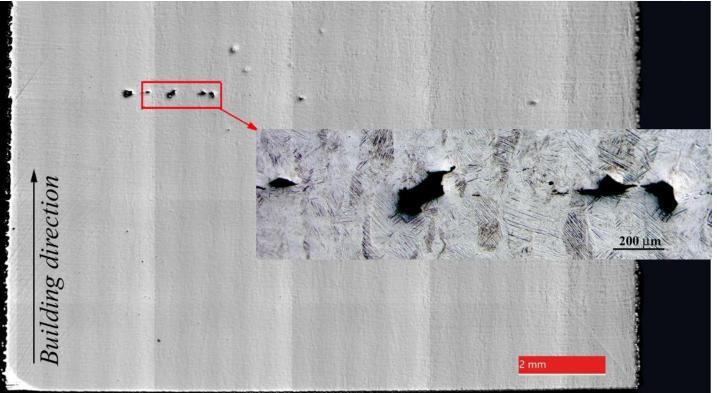
#### Intentional stop-start flaw

- Can be seen in witness
- Not present in this case in bracket

- Scans of complex part still needed
- More work is needed to understand the formation of layered flaws and their extent across the build plane
- Can be seen in witness specimen by microCT

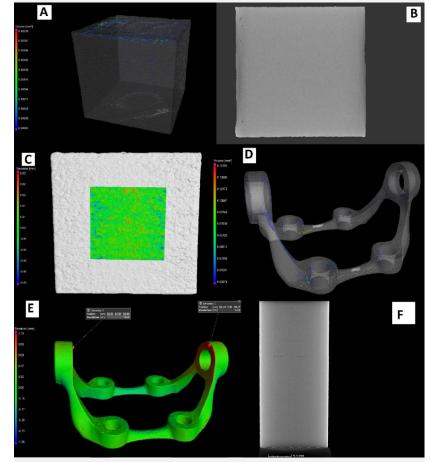
#### Set of parts selected to send to 10 microCT labs

- 10 mm cube (upskin porosity)
- Witness cylinder (intentional stop-start flaw)
- Complex bracket (contour porosity)

- All labs could positively identify the porosity distributions
- Especially the stop-start flaw was no problem
- To the right: one of the set of results as example showing a series of completed analyses using pre-set X-ray CT scan parameters and image analysis steps (a recipe).
