Case Studies in Nondestructive Testing and Evaluation

X-ray computed tomography of a titanium aerospace investment casting

Anton du Plessis ^{a,b,*}, Pierre Rossouw ^c
^a CT Scanner Facility, Stellenbosch University, Stellenbosch 7602, South Africa

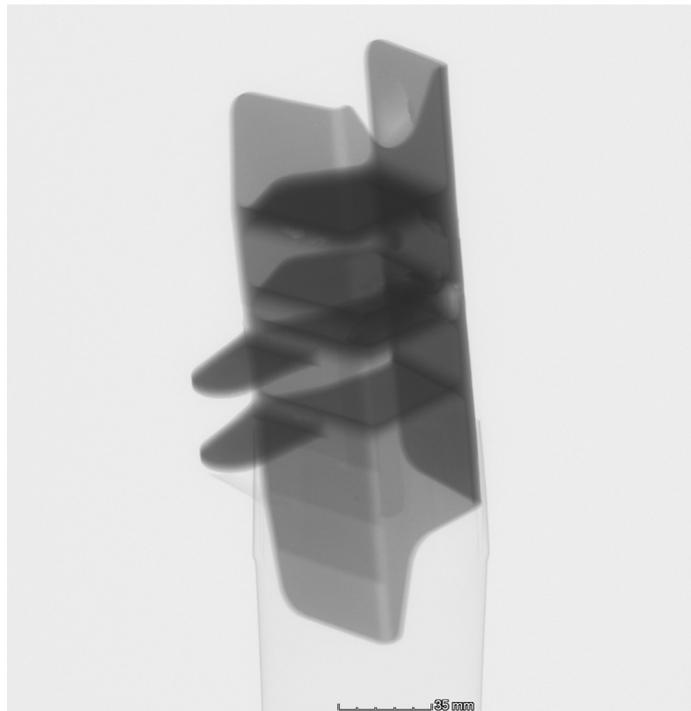
Fig. 1. Digital X-ray image of investment casting.

Digital X-ray projection images are recorded, of which one example is shown in Fig. 1. Clearly, it is possible to use this type of image for quick part inspections, as well as move the sample around and view sections at higher resolution in 2D. For best CT results, the sample is mounted at an angle in order to minimize artefacts in CT reconstruction. In the case of a digital X-ray image, pores are visible as brighter areas, while solid regions are darker. However, thicker regions along the line of sight of the X-ray beam are also darker. Therefore major defects are visible but the difficulty lies in the complexity of the component, causing difficulty in an unbiased assessment of the defects using 2D radiography alone.

An X-ray microCT scan involves recording thousands of digital X-ray images as in Fig. 1, at various angles around the object during a slow rotation of the object. The 3D data set is reconstructed from the digital X-ray images, to generate a volume data set. This data can be visualized and analyzed in different ways, and comprises volumetric pixels (voxels) at every point in the scan volume, with a grey value representing the density and atomic mass of the material at that point. The resolution of the image and detail detectability is limited by the focal spot size of the X-ray source, the geometrical magnification and the digital X-ray detector. In this work the resolution was 0.158 mm. The sample size limits the achievable resolution due to geometrical magnification and a finite detector size. This follows a roughly linear relationship – the “factor 1000 rule of thumb” is that if a sample is 50 mm wide, 50 μm resolution is achievable, for example. This is one of the limitations of the technique, since defects or features smaller than twice the scan resolution will not be detectable under most scan conditions. Hence the smallest defect positively identified in this scan would be approximately 0.3 mm in diameter. However, high scan quality can improve the situation slightly, and surface determination can have accuracy as good as the scan resolution.

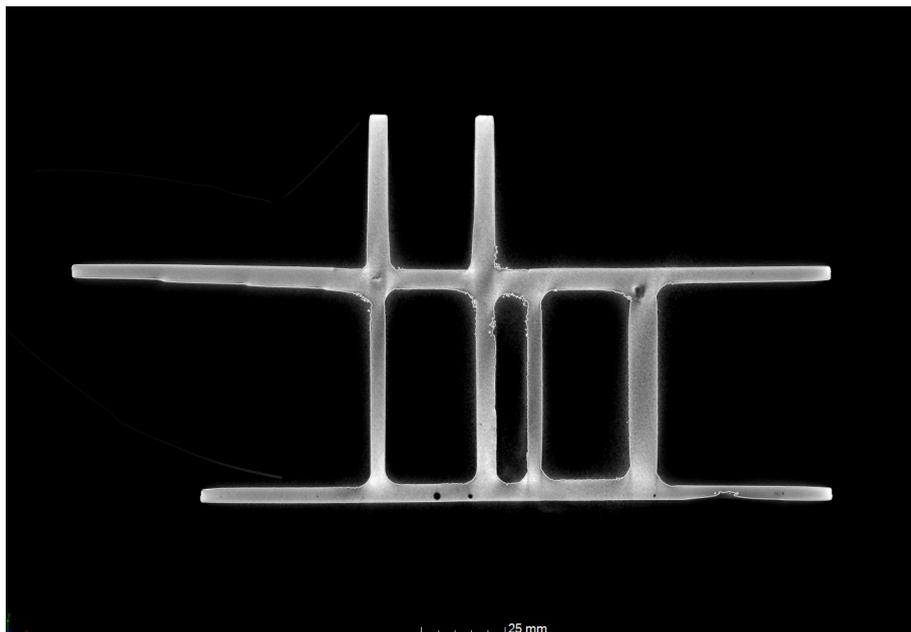
Fig. 2. CT slice image of the casting.

Virtual sectioning can be applied to the sample in any direction. Fig. 2 shows such a CT slice image, where brighter regions correspond to more dense material and dark areas represent air, hence black spots are voids. Some beam hardening artefacts are seen in the form of bright and dark image effects, but these do not affect the defect analysis, at the levels here. This type of image artefact can become overwhelming when larger or more dense parts are scanned which limits the applicability of the method, especially for automated analysis as presented here, to smaller samples and lighter metals. However, even though this limitation might become problematic for automated analysis and striking 3D images, simple slice

images can still be used effectively to find defects even in images with significant artefacts. Slice images are the simplest form of CT data analysis – i.e. scrolling through 1000 images from one side to the other through the object, and no special software is required for this viewing.

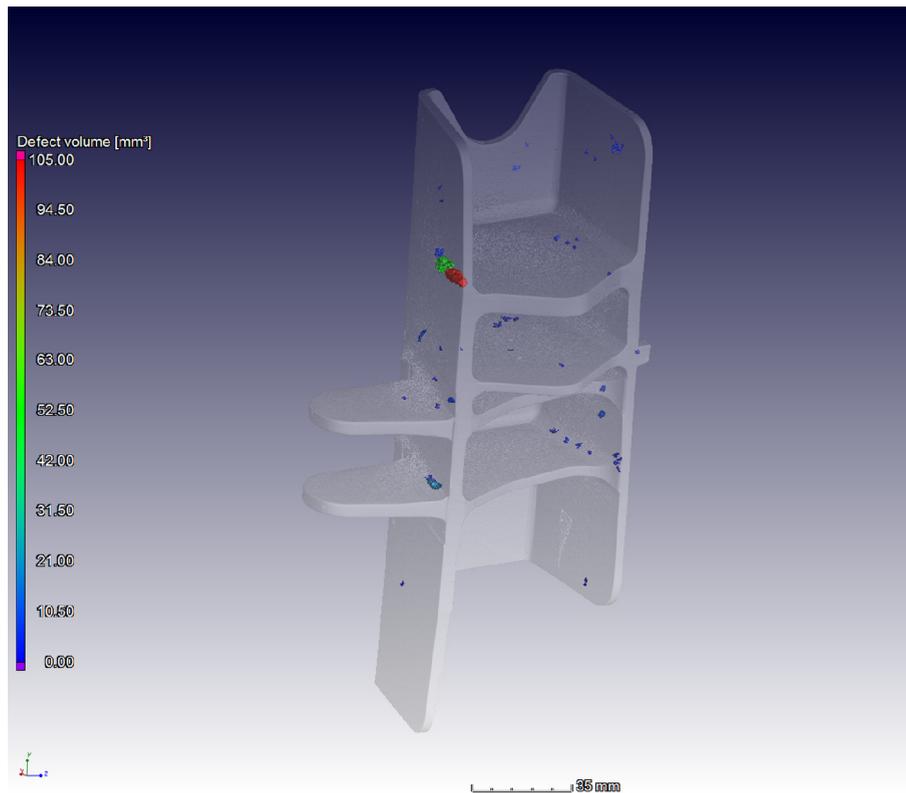
Fig. 3. Defect analysis indicating the location, shape and size of each defect larger than 2 mm.

An automatic defect analysis was performed on the microCT scan of the sample, this involves finding voids and classifying them, in this case according to volume. Largest voids are coloured in red, smallest in blue and the 3D image made semi-transparent to view the location, shape and sizes of the defects. This is shown in Fig. 3, while additional material includes a 3D rotation video of this analysis. Such videos provide a good overview of the analysis, while a self-rotation in

any direction is possible in the software. In this example defects smaller than 2 mm diameter were excluded to simplify the analysis. The defect analysis results can be further analyzed and sorting can be done based on surface area, shape factor e.g. sphericity, or the information can be represented as a histogram of void sizes, such analyses are interesting for advanced materials analysis studies.

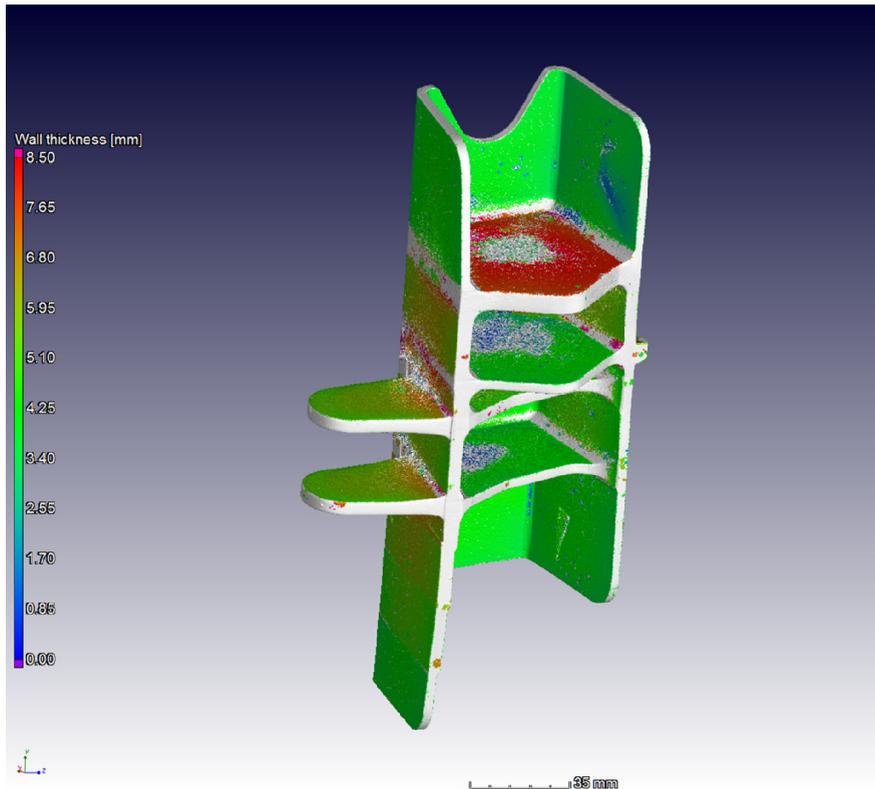
Fig. 4. Wall thickness analysis of the casting.

Another automatic analysis possible is wall thickness analysis. This calculates the thickness of walls in the object. These results can be visualized by colour-coding the walls based on their thickness. Fig. 4 shows the 3D image result, with most walls in the region of 4–5 mm. A single thick wall of about 8 mm is seen and a dent in the side of the object on the top right produces a thinner region of about 2 mm. Once again, the limitation on this automated analysis is the lack of image artefacts, thereby allowing an accurate surface fit, which is the basis of the wall thickness calculation. The surface fit function finds the interface between material and air in 3D space, and this interface is not clear under conditions of image artefacts.

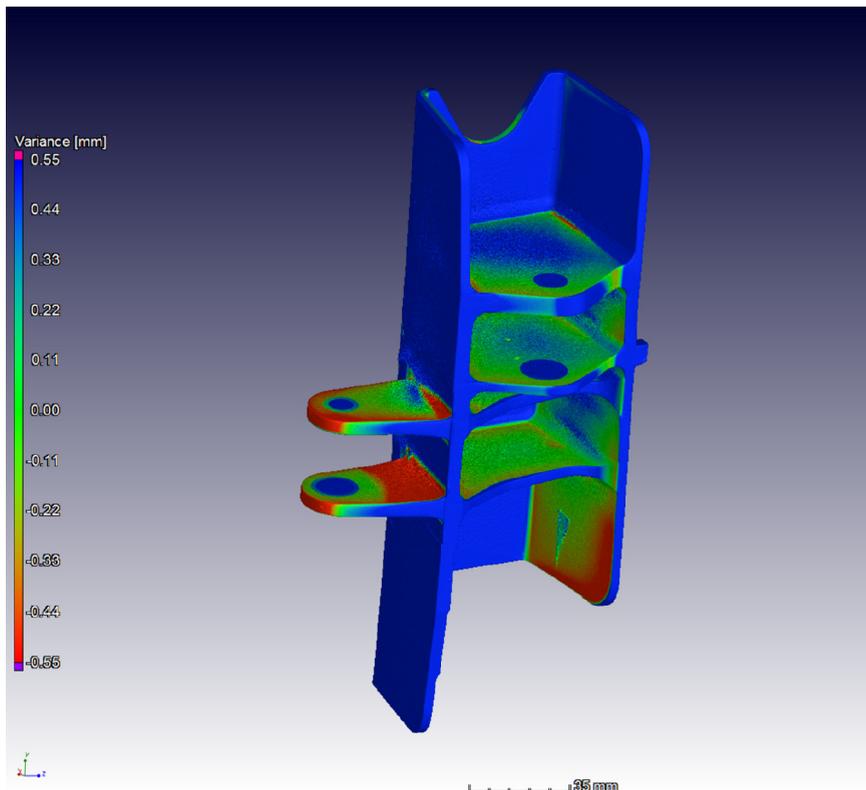
Fig. 5. Part to CAD comparison of the casting.

The CAD file (STL format) was loaded and used for a comparison with the scan data. This involves a surface fit to the scan data, a best-fit alignment of the fit-surface scan data to the CAD data, and an automatic calculation of the deviation between the two. The results are shown in Fig. 5, where the deviation result is shown with colour-coding from red to blue for the two extremes. The part was supplied as-cast, and therefore the CAD file was within (inside) the scan data in most places (blue) but at some places the scan data was within the CAD data, which means that shrinkage could have occurred. Besides understanding where to do post-casting machining, angular and other deviations become visually clear, as the top left region shows. More detailed analyses can be done within the analysis software or the CT data can be exported as a CAD file (STL format) for analysis by design engineers in their own CAD softwares.
